DRAG CHARACTERISTICS OF NEWLY APPLIED MARINE COATINGS AND POTENTIAL APPLICATIONS IN COMBINATION WITH ULTRASONIC DEVICES

Maxim Candries

2nd International Symposium on Corrosion and Fouling, Antwerp, 1 April 2019

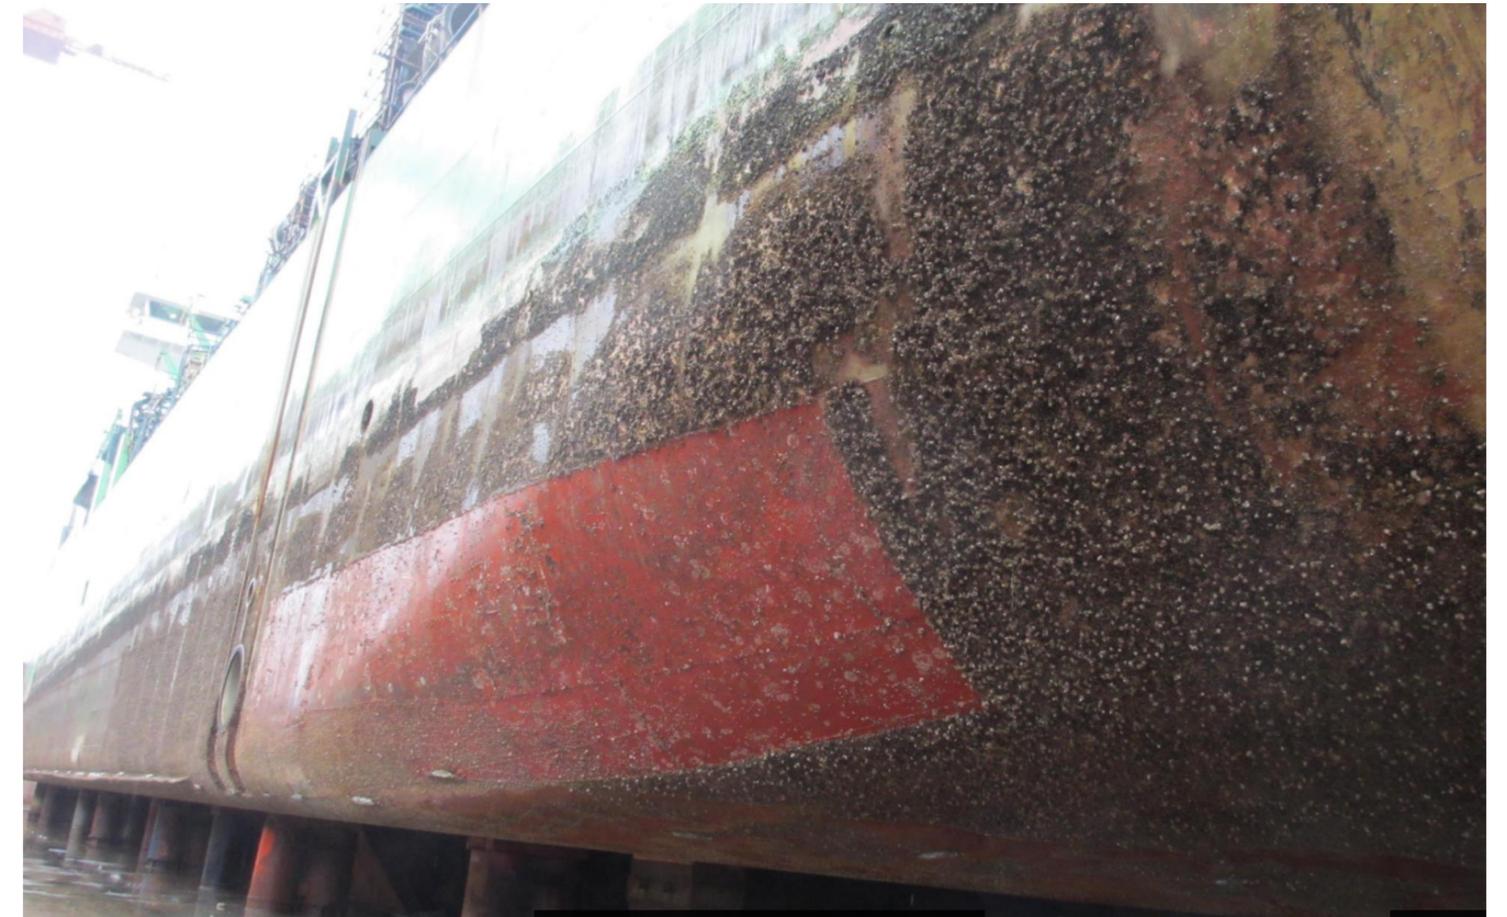
- Photographic records taken in drydock have shown that dredging vessels of DEME can be covered with heavy calcareous fouling over a large extent of the wetted surface area.
- DEME is considering to apply alternatives in replacement of the copper-containing antifouling coatings that they normally use.
- One coating that was proposed, is a novel hard nanostructured coating that claims 6% drag reduction
- Investigate the roughness and boundary layer characteristics of three commercial coatings
- Roughness and boundary layer characteristics of coatings are compared
- Perform an in-situ evaluation in combination with an ultrasonic device

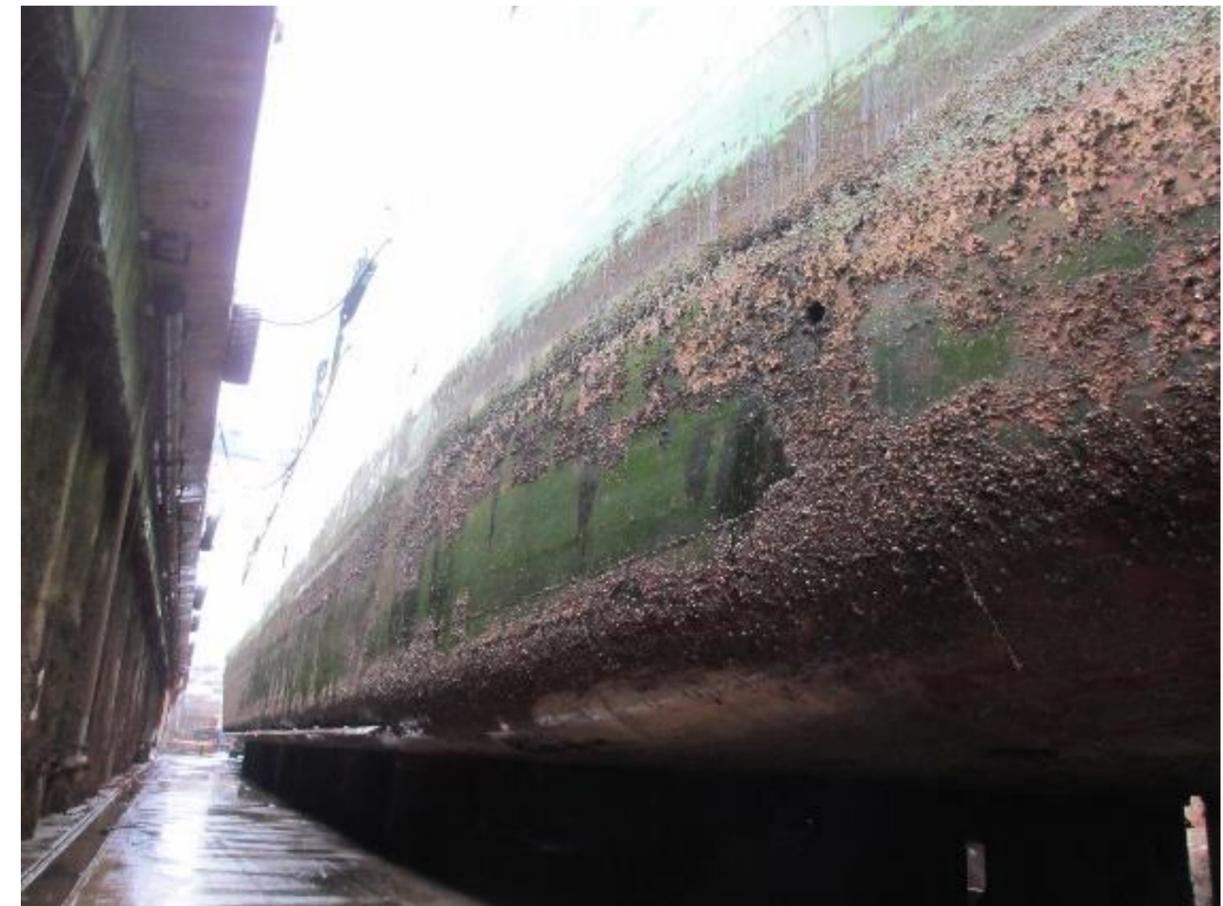
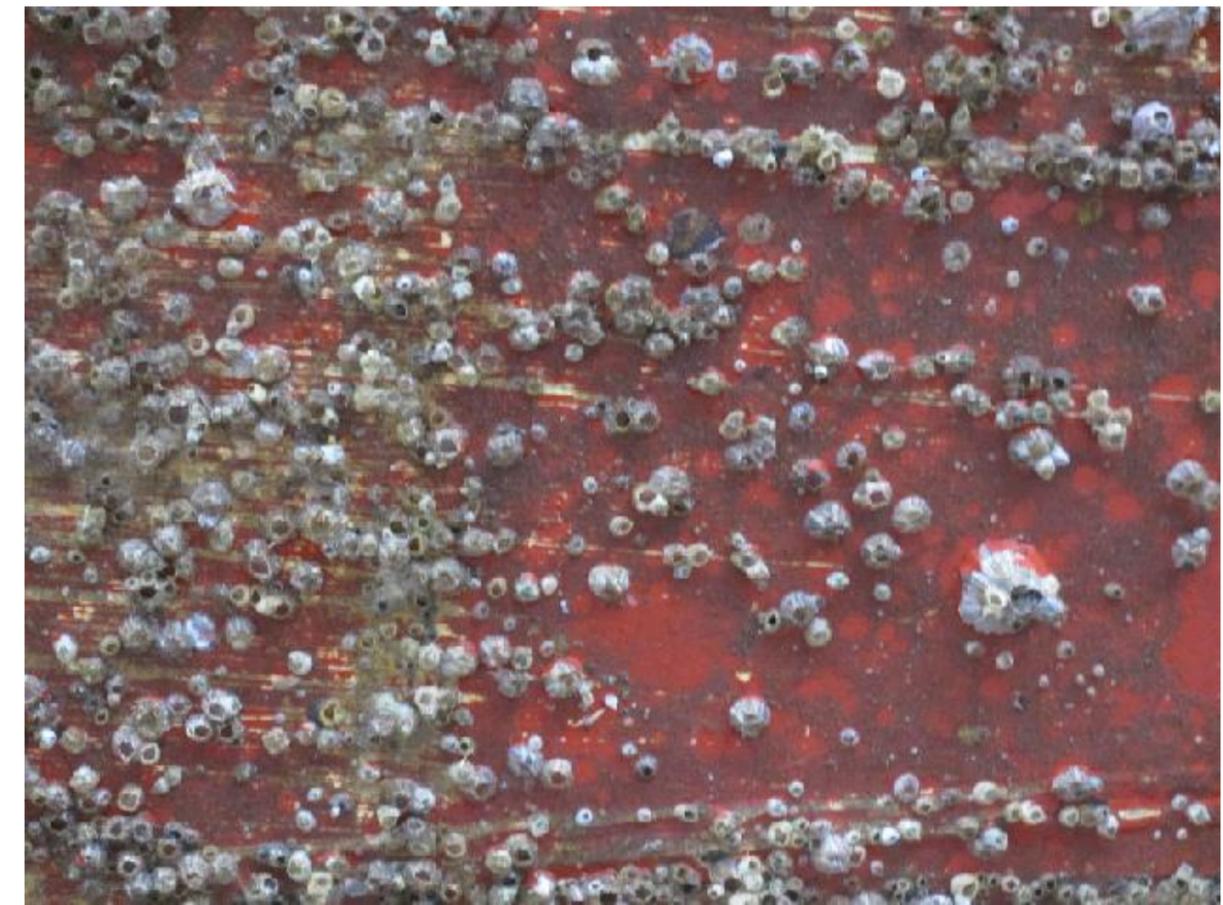
- Commissioned by Dredging International (DEME)
- These vessels are a lot of the time operational at low speeds (dredging mode), often in tropical waters
- After drydock observations, alternatives, preferably without biocides, are sought to replace standard tin-free SPC (=Coat-1)
- Two candidates, new on the market, which both claim significant drag benefits:
- **Coat-2:** A new generation Foul Release system with added biocides for extra fouling defence, suitable for vessels with long idle periods, which in this case are better called “very active” periods
- **Coat-3:** A novel biocide-free “nanostructured” coating that would be combined with an active ultrasonic antifouling device

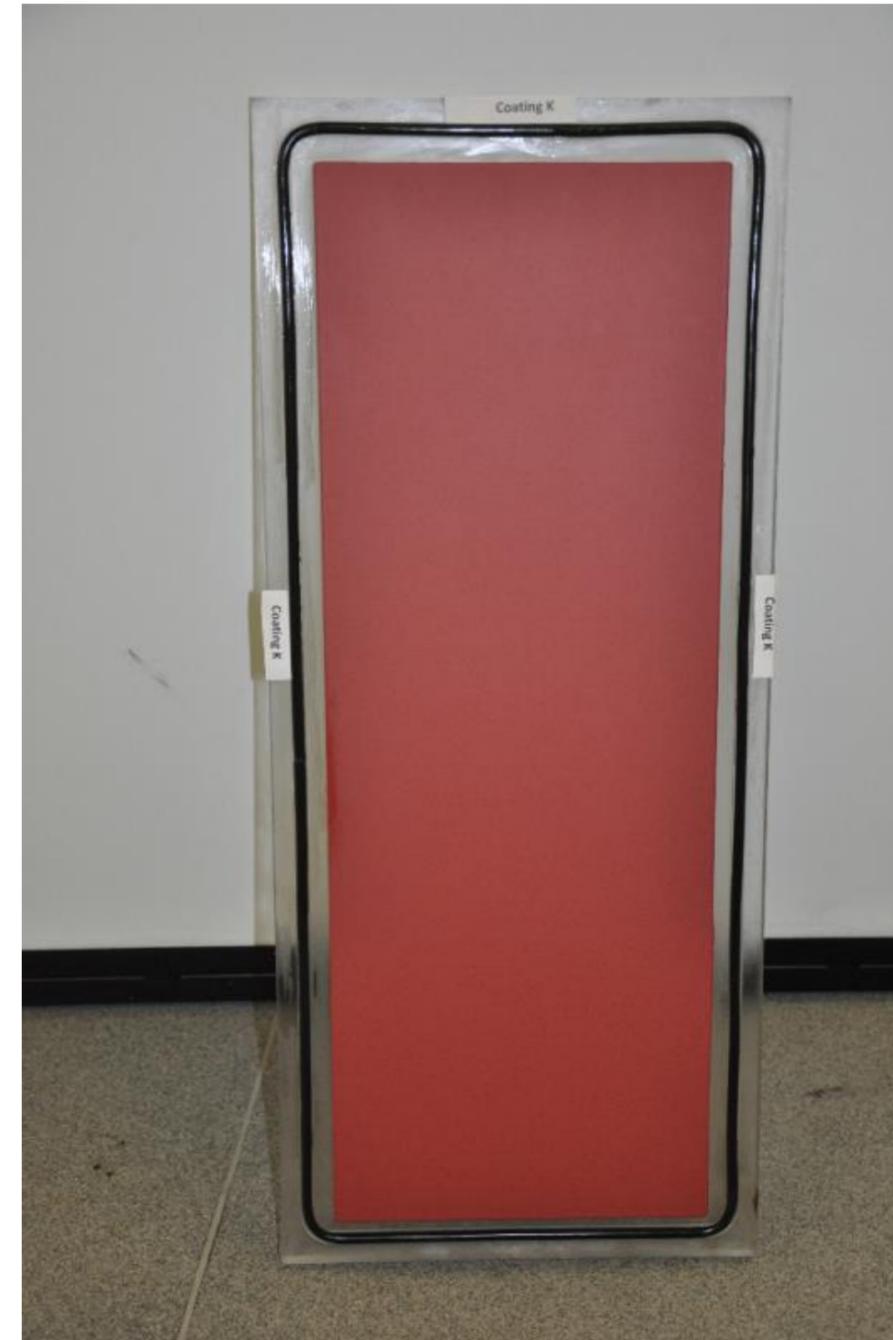
- "high speed insert"
- Test specimens have a 218 by 598 mm² coated area
- Preferably on acrylic substrate

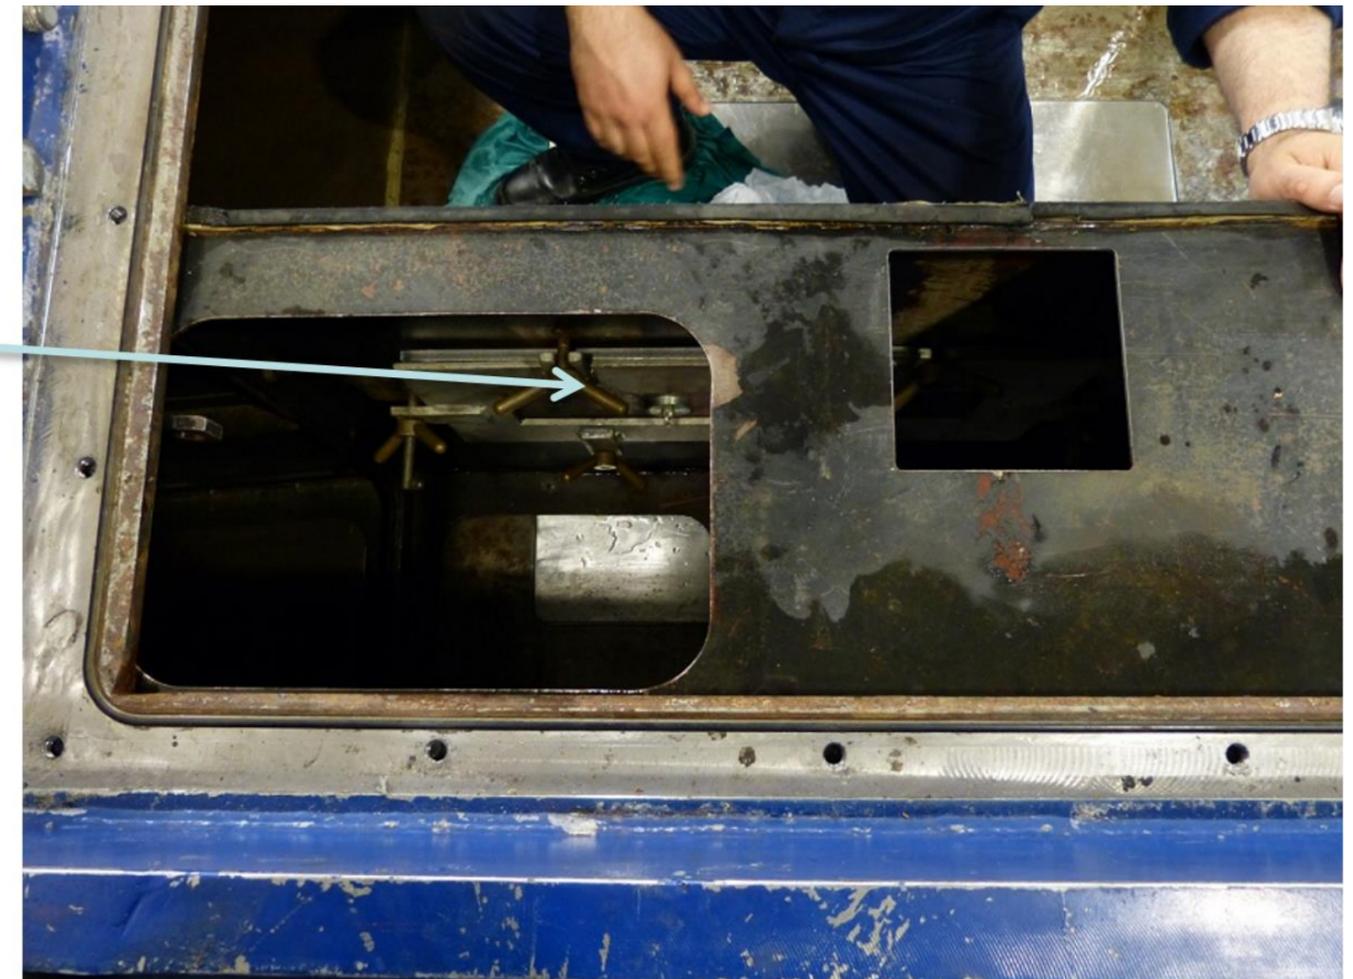
- Test specimens can be replaced rapidly (in 1-2 hours);
- 5- 6 boundary layer profiles \rightarrow 1 coated surface can be tested per day;

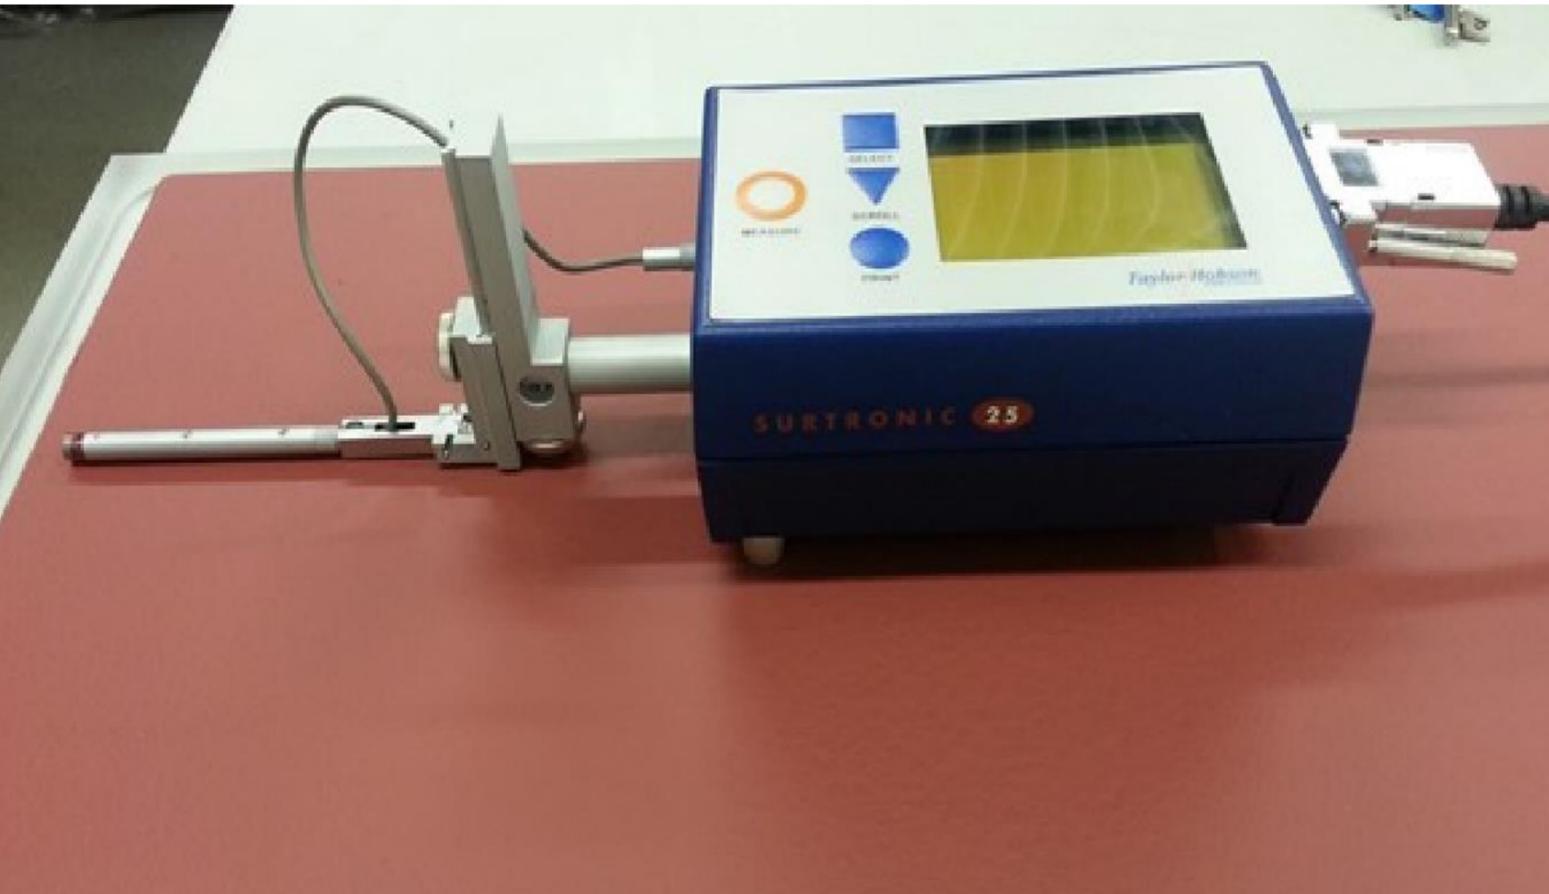
- Roughness characteristics of same test specimens are measured with optical laser profilometer (Uniscan OSP100) and stylus instrument (Surtronic 25)

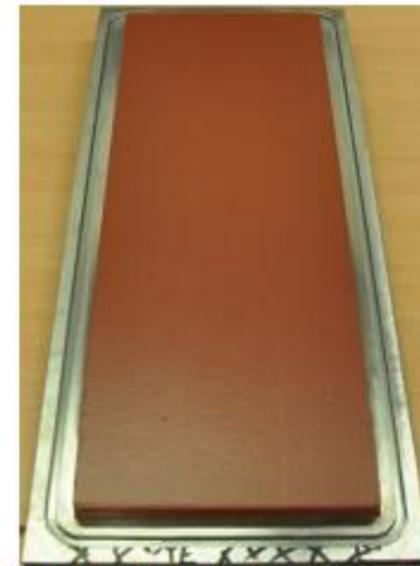
a. Coat-1 before hydrodynamic testing

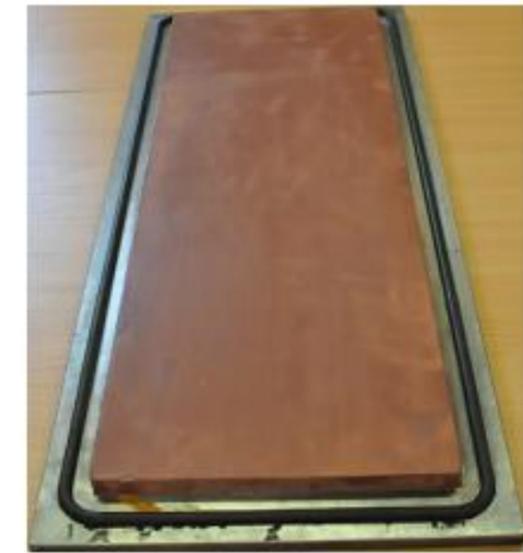
b. Coat-1 after hydrodynamic testing

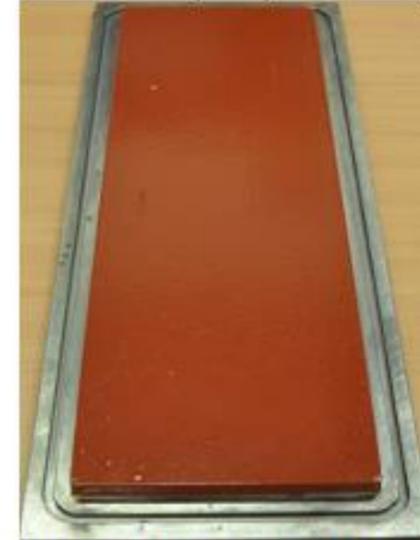
c. Coat-2 before hydrodynamic testing

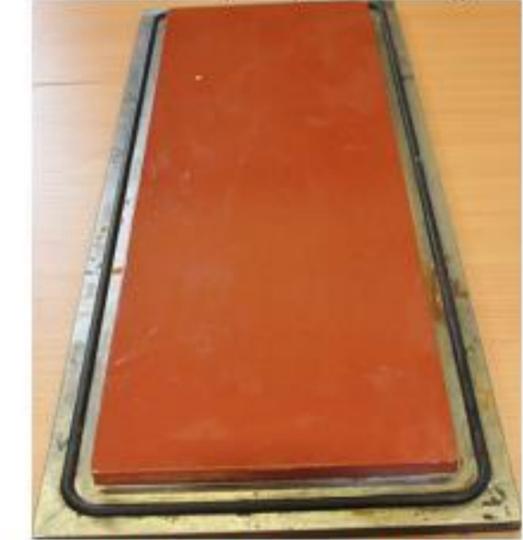
d. Coat-2 after hydrodynamic testing

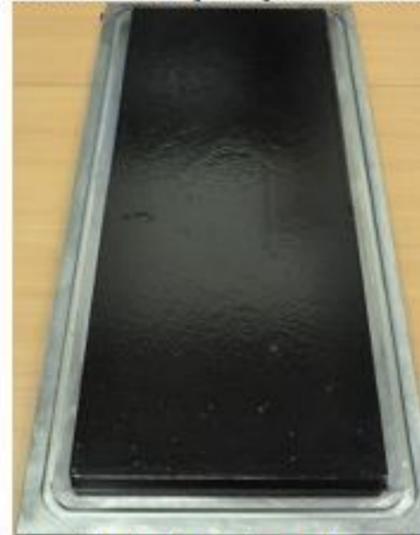
e. Coat-3 before hydrodynamic testing

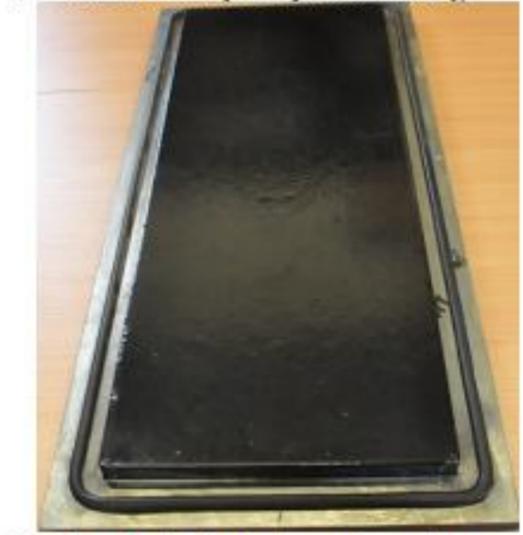
f. Coat-3 after hydrodynamic testing

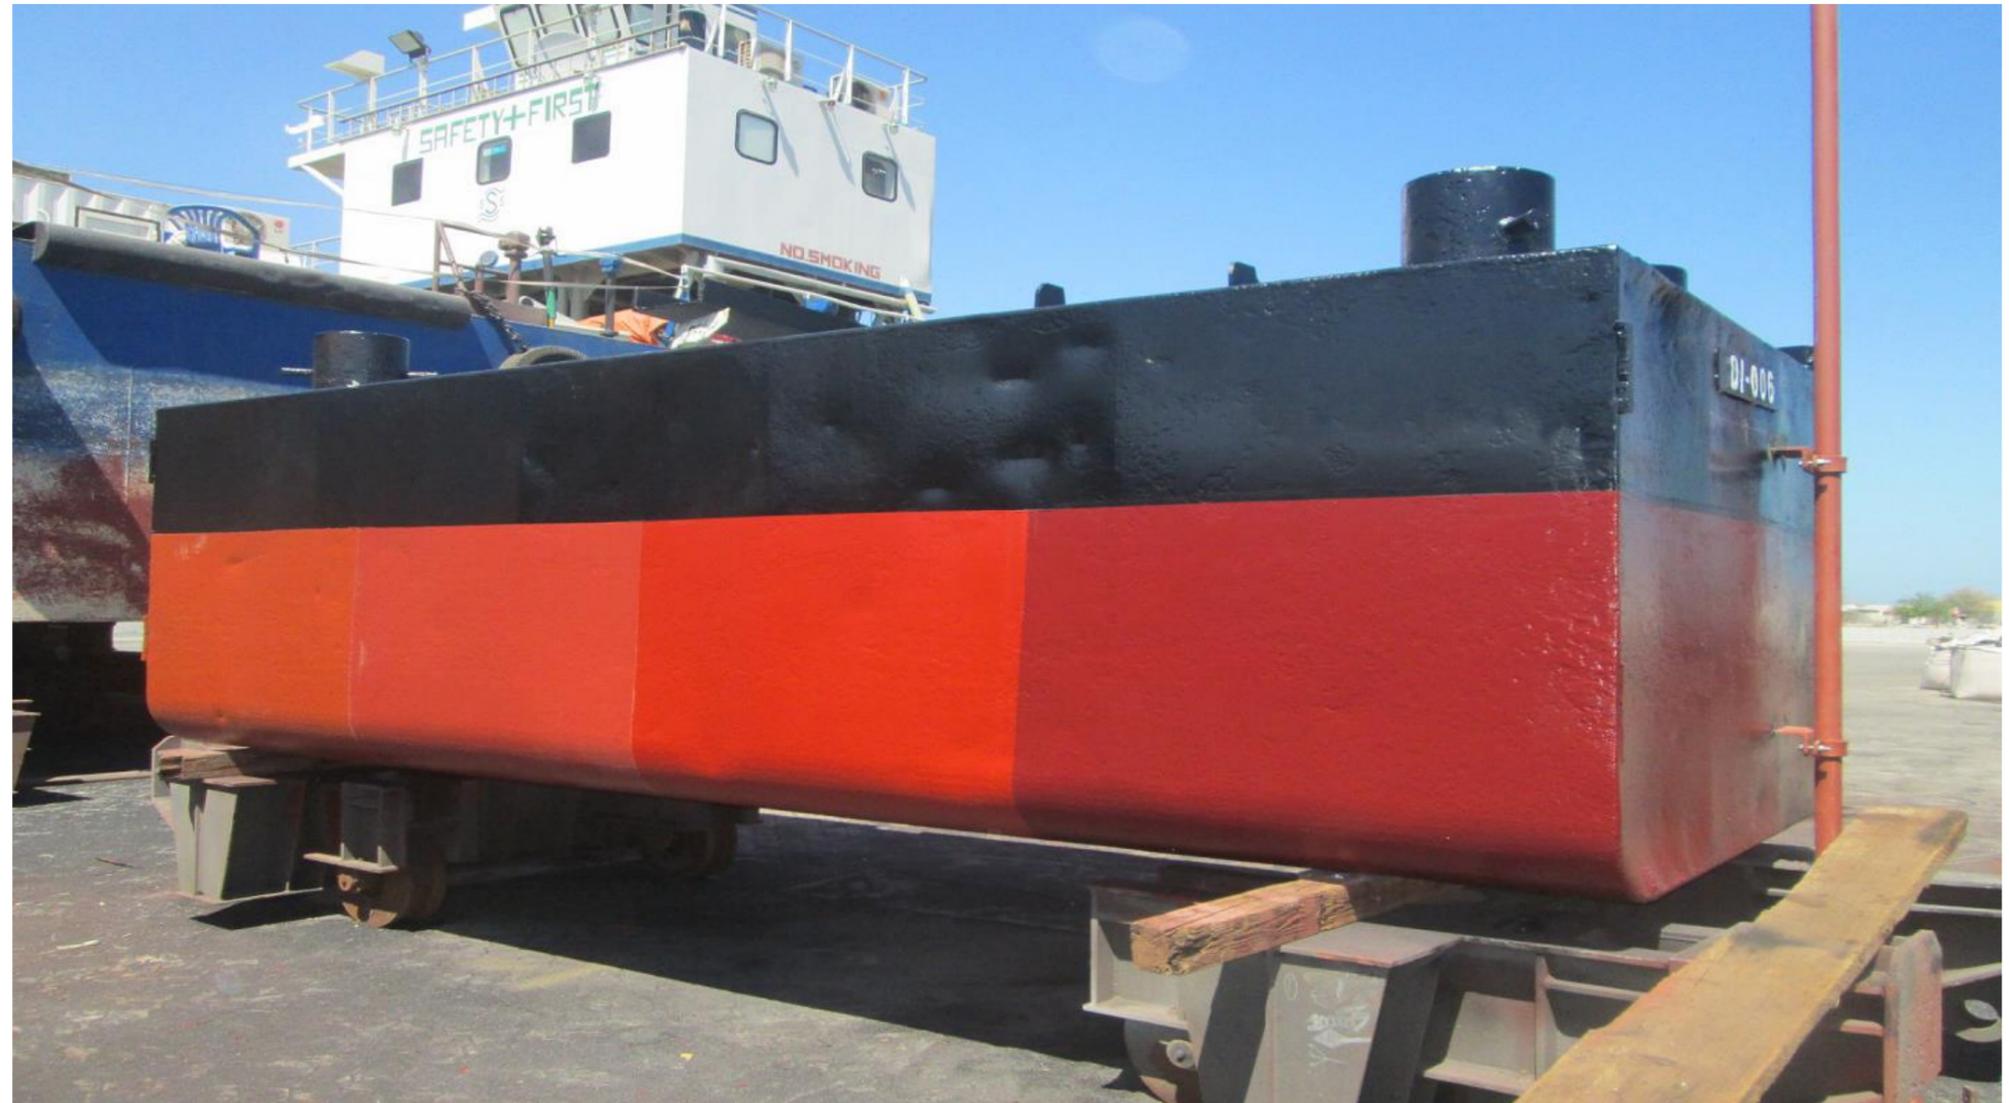
- Three tested coatings + anticorrosive primer were applied on four pontoons (5 m long, 2.2 m wide)
- Exposed over 6 month period (May – December) in Persian Gulf

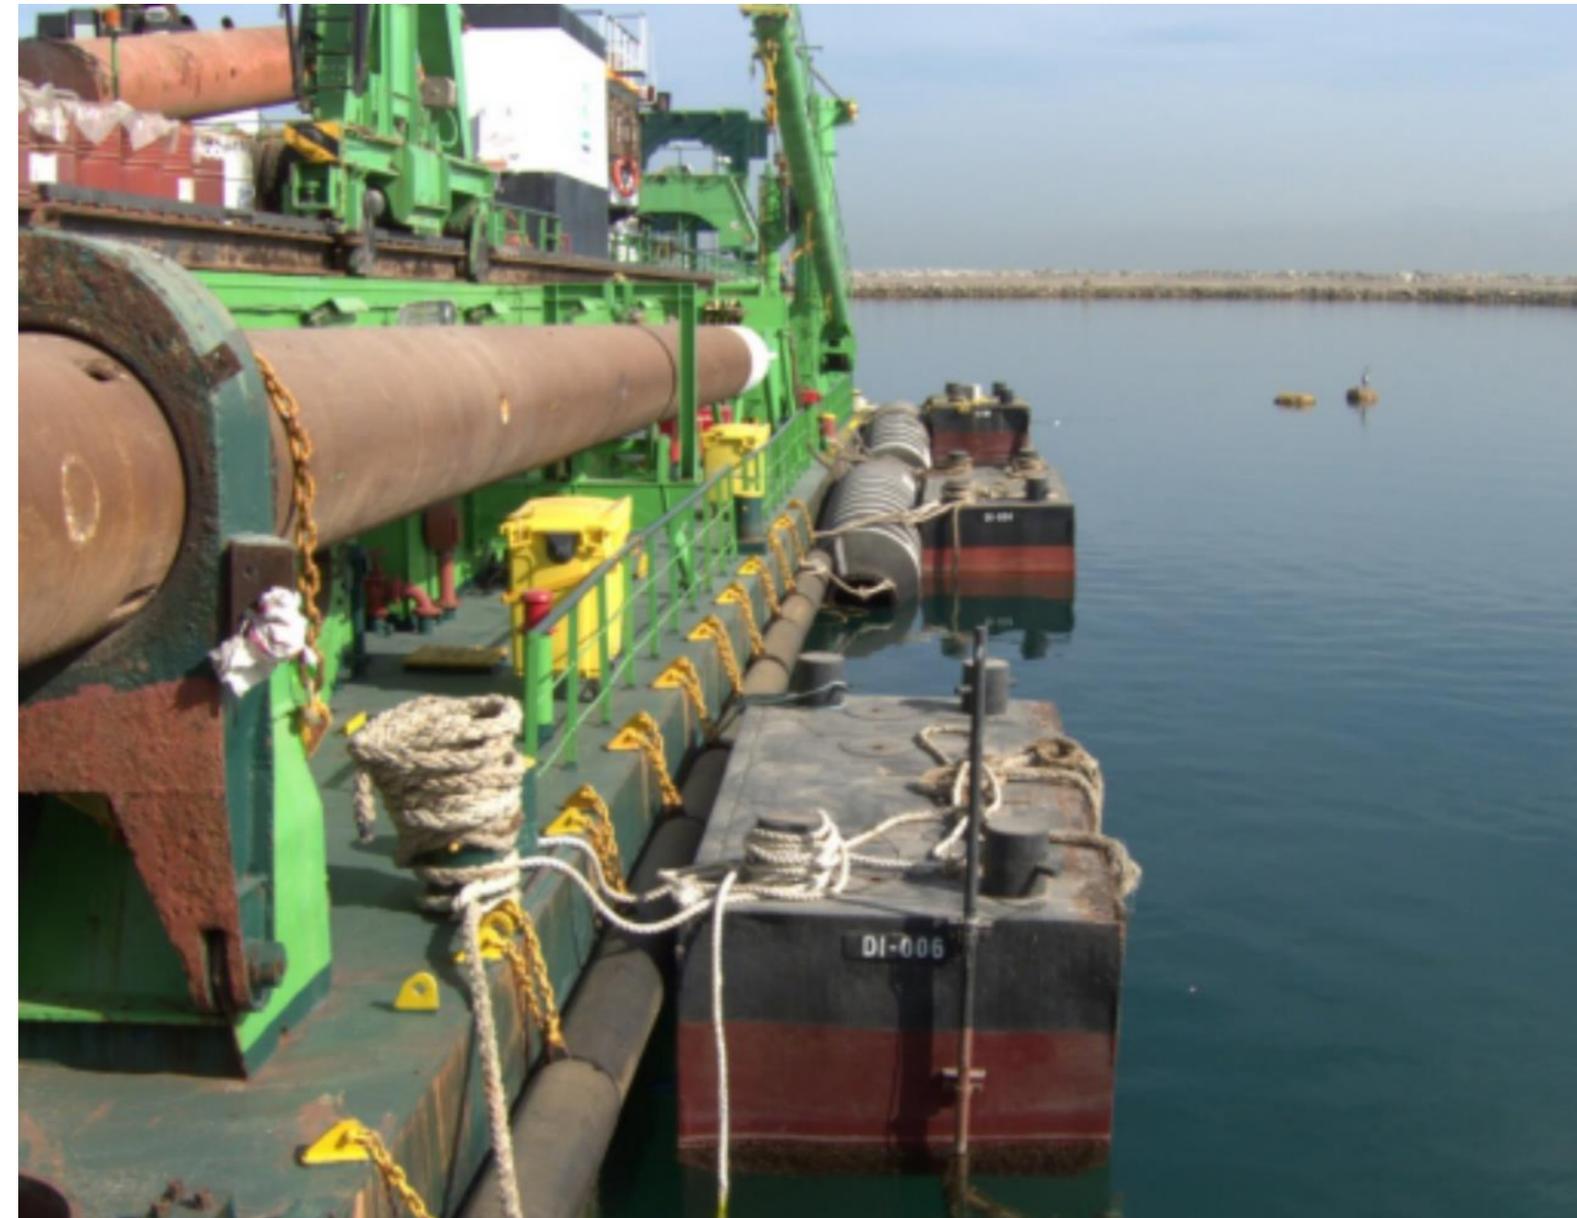
- The pontoons were located at the starboard side of the 65 m long cutter suction dredger “Kallo”
- The probe of the ultrasonic antifouling device was attached to pontoon DI-06, located at the aft stern, and was connected to the power supply of the “Kallo”.
- pontoons DI-04 and DI-09 were positioned at a distance of approximately 20 resp. 40 m towards the bow. Pontoon DI-08 was put at a distance of 150 m from the other pontoons.
- This set-up would allow to evaluate the effectiveness of the USAF device with increasing distance from the sound-emitting probe.
- Intermediate underwater surveys were carried out in June and in August.

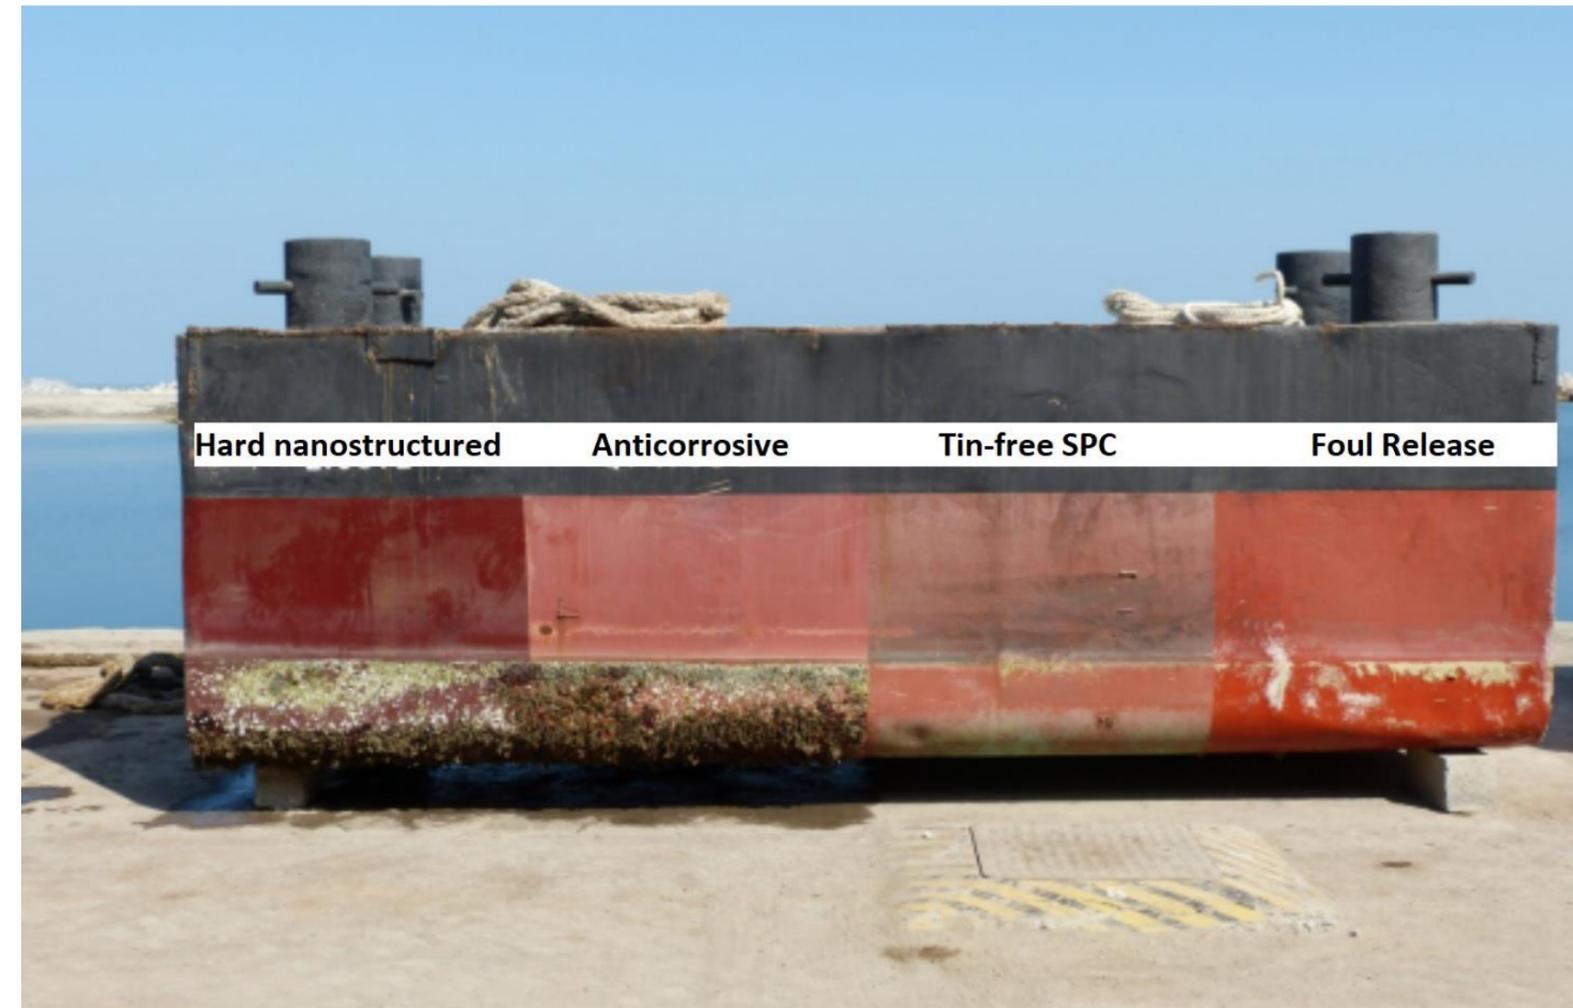
- Power cut occurred during the testing period
- Tin-free SPC and Foul Release perform well
- Evident fouling on nanostructured and anticorrosive

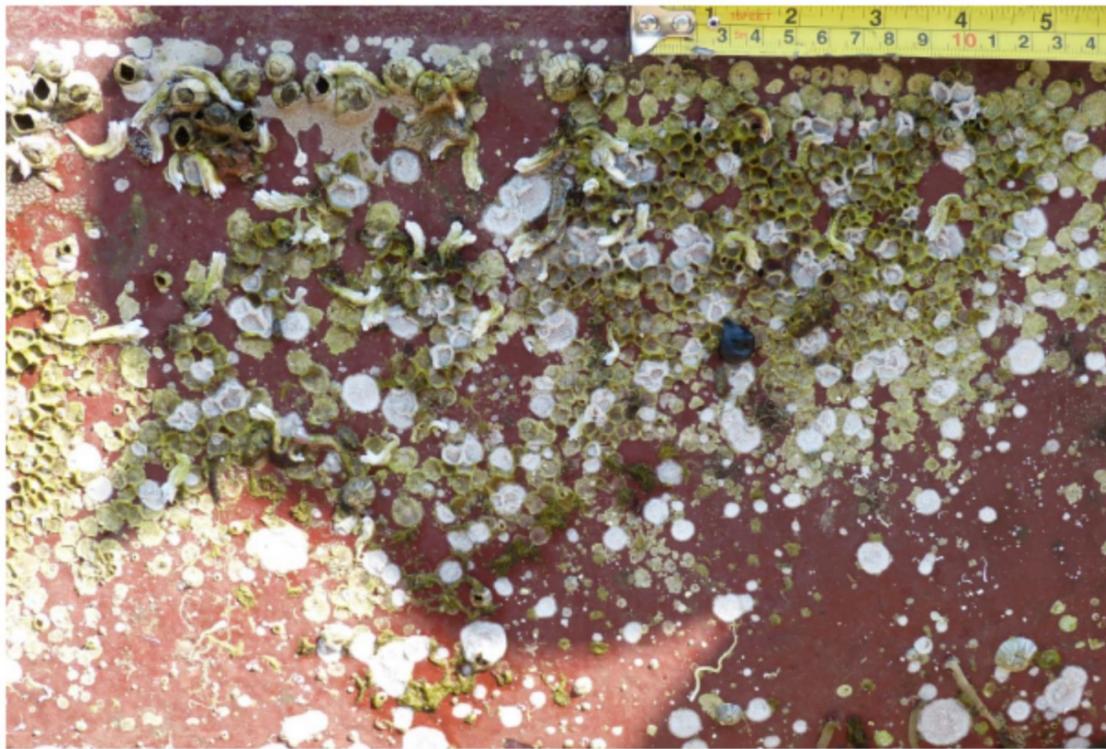
- NSTM ratings: A clean surface (FR0) will first be fouled by a slime layer (FR 10 to FR20), followed by weeds (FR30). This is followed by hard fouling from early to mature stages (FR40 to FR90)

Nanostructured: FR70-50%, FR20-50%

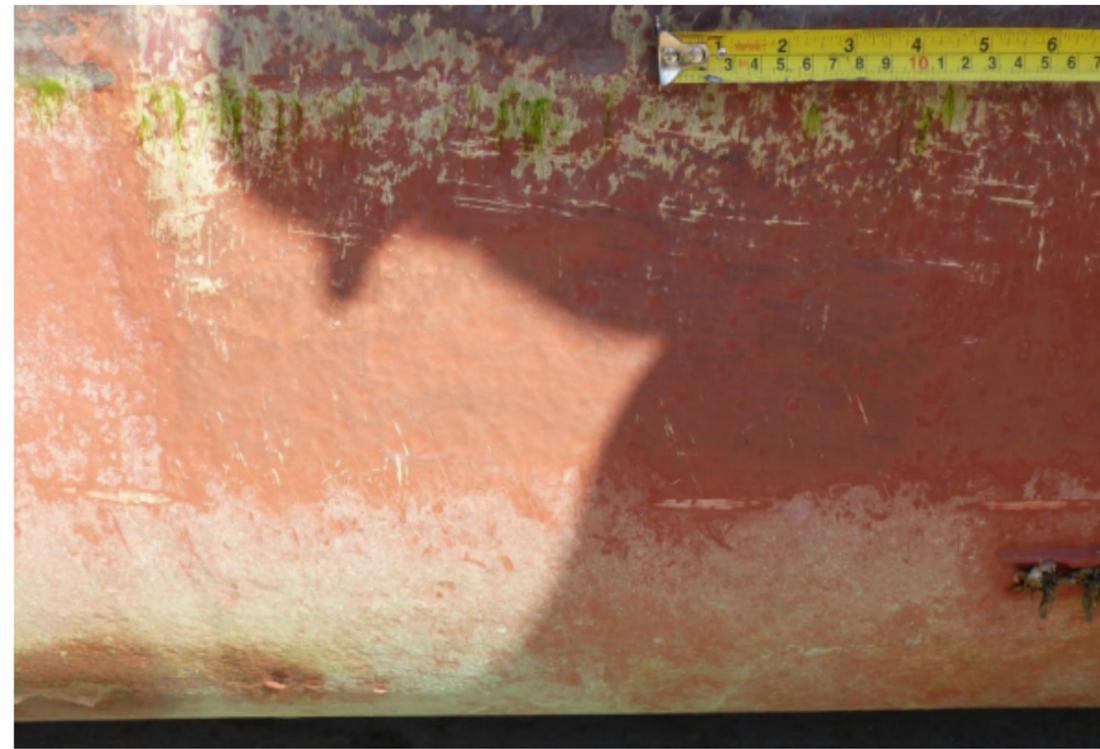
Tin-free SPC: FR10-80%, FR20-20%

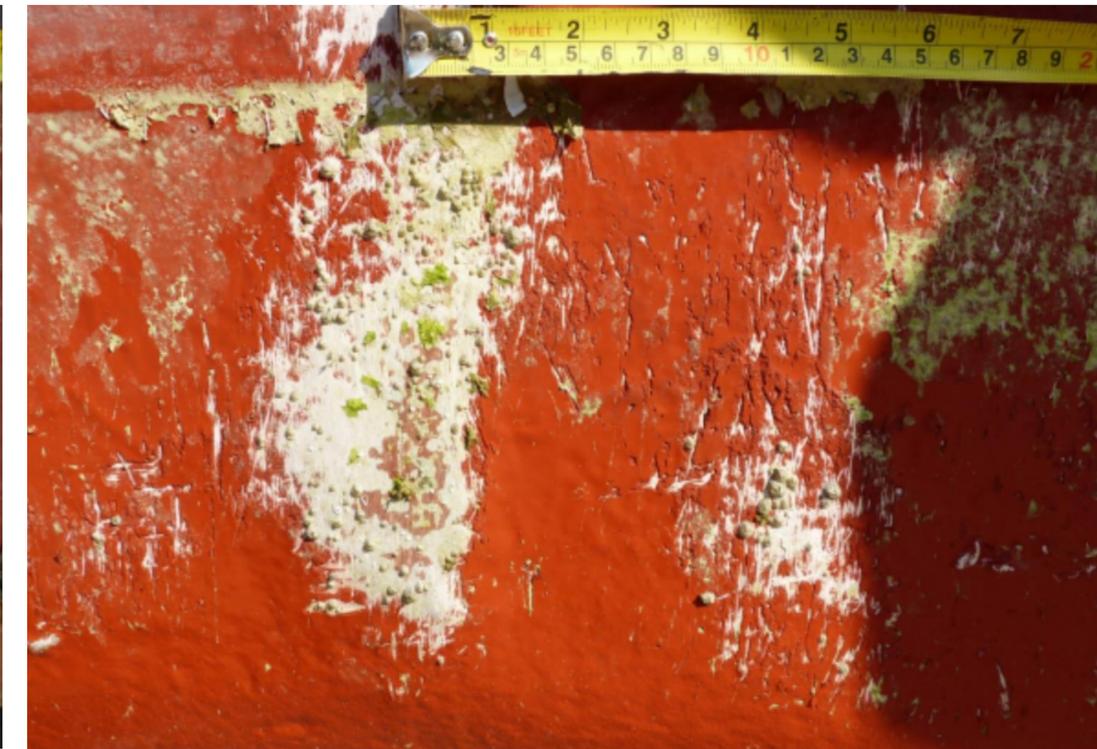
Foul Release: FR10-60%, FR-20%, FR0- 20%

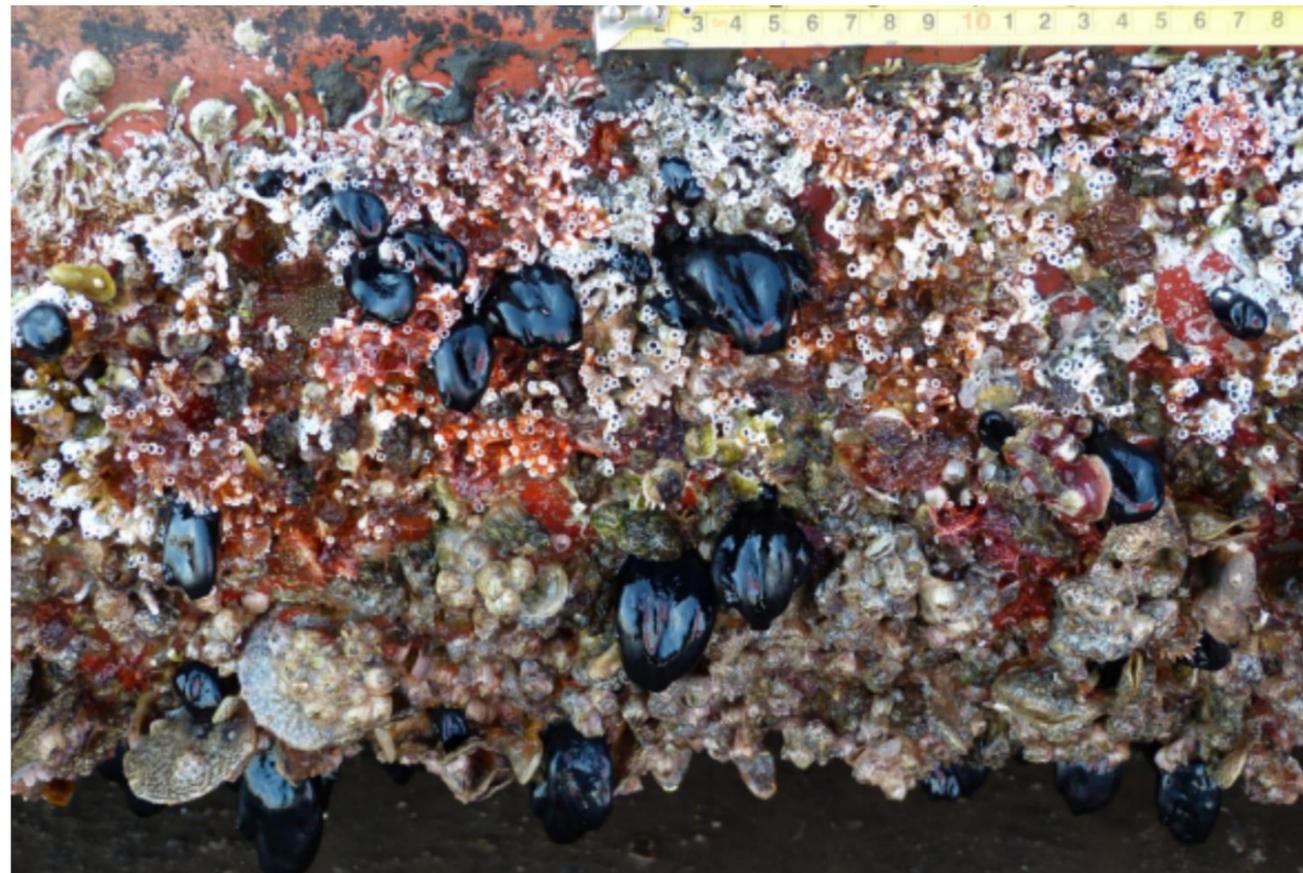
- Pontoon 8

Anticorrosive: FR90-100%

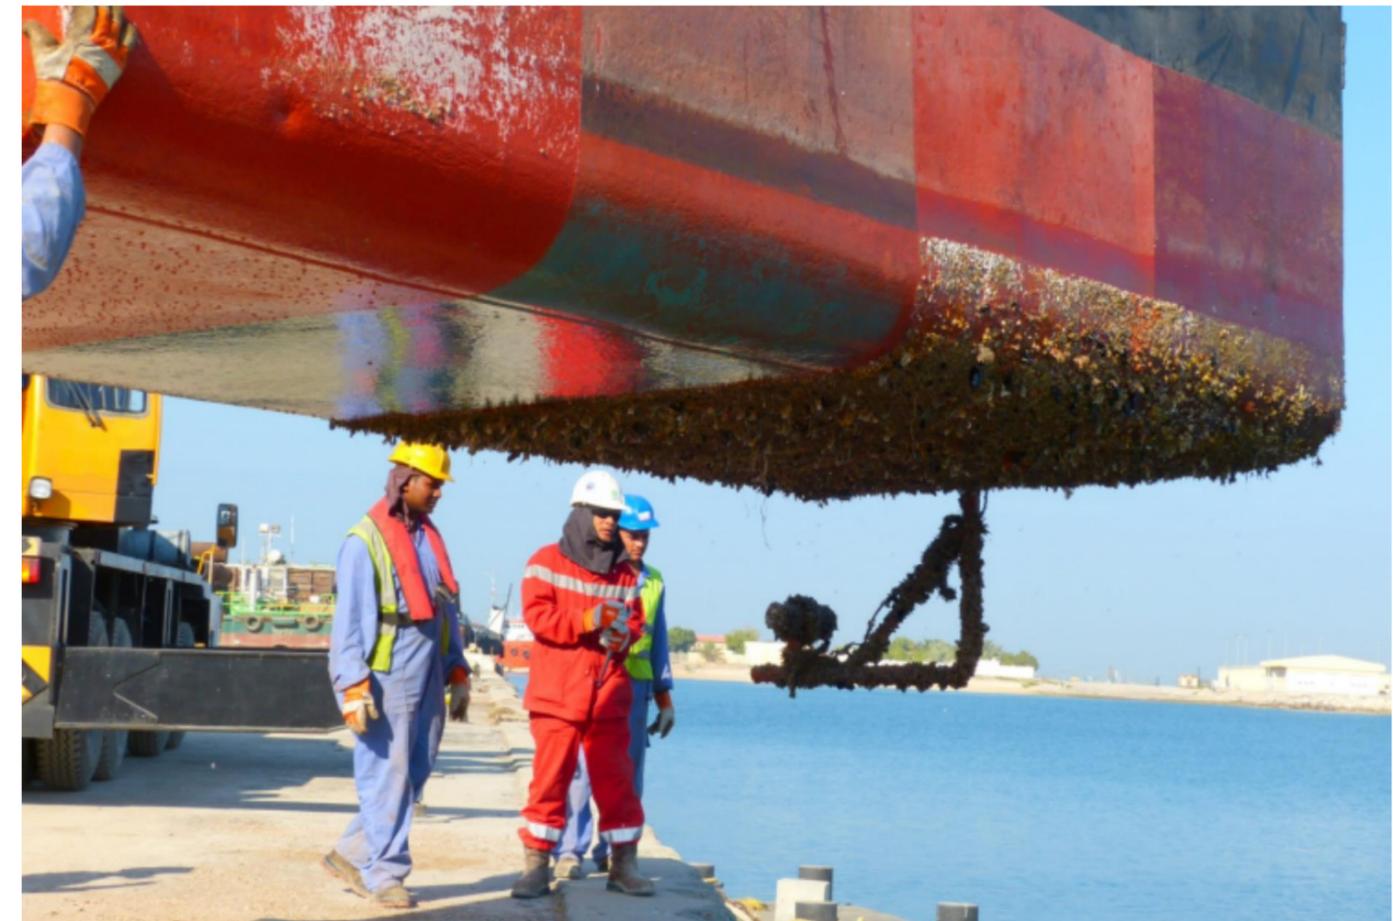
Nanostructured	Anticorrosive	Tin-free SPC	Foul Release
	Overall FR	56	68	11	7
Pontoon DI-06	port	45	52	10	10
	starboard	49	55	10	9
Pontoon DI-04	port	60	64	6	2
	starboard	61	66	10	4
Pontoon DI-09	port	50	69	12	2
	starboard	55	61	15	9
Pontoon DI-08	port	38	86	9	7
	starboard	90	90	12	11
